A Closer Look at the Timber

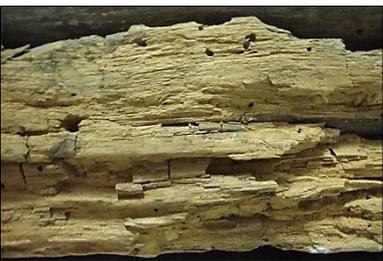
Decaying Oak (above) and BECHS timber (below).

At this point it is critical to explore if the timber we have was (or was not) one of these "new cut" timbers. We know the last use of the timber was in the construction of Meagher's hardware store as a floor joist. This accounts for the square cut portions of the outer edge of the beam as it lay facing up in the store. We know that it spent its time with this side up because that surface suffers from a permanent discoloration. The logs of a late 1860s log home that we have been using for a comparison, display the "this side up" look just like Meagher's beam. However, the decay is not characteristic of oak, a mosaic pattern, per local examples.

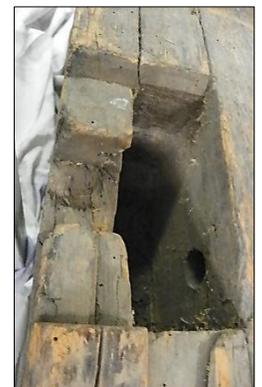
Blind/shallow mortise hole

Regardless of the timber's possible use in the gallows or not, there are blind/shallow mortise holes on the side opposite the notches that don't make sense. We know that Meagher's floor sill would have no need for mortise holes in those locations because they would have been sticking out the side. We also know the mortise holes would not have been used as knee braces for the gallows because

Therefore their presences demonstrate that this beam was not one of the 1861-1862 "new cut" pieces for the scaffold, and it had a previous use before being used in Meagher's building.

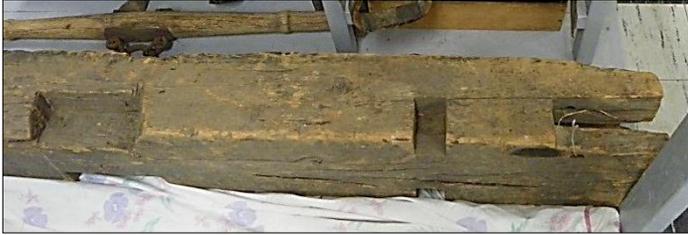
It also appears that the timber was never any longer on one end than it is right now. On the half with the four alleged hanging positions, the blind mortise hole on that side is very close to the end and the wood broke out

when it was disassembled the first time it was used. Had the timber been longer, there would have been adjoining support that it would have prevented it from breaking out of the adjoining wood, as it appears in the other three blind mortise holes. That end of timber had to have been originally as long then as it is today. If

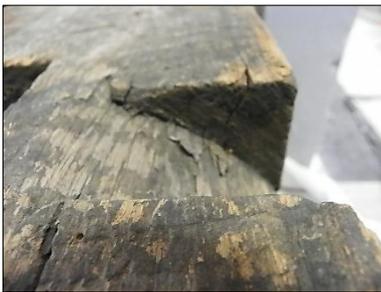
Meagher's story was true, it would have been longer to give that mortise area support. Also, the gallows had tenon joints on both ends, so the timber would have had to be longer to account for that as there are no tenon joints on the BECHS timber. This is also the only end that is rotting. Wood rots from water intrusion on the ends. The other end is not rotten suggesting it is the end Meagher would have cut off to fit the floor sill at a later date.

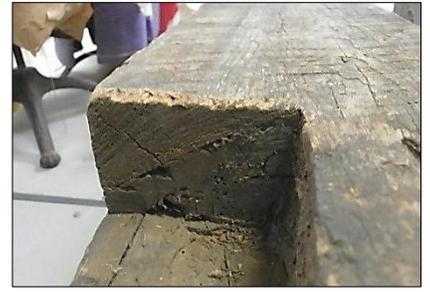
Entire timber view, Floor Sill "This Side Up"

Another note to consider, the notches and the joist hangers (two different purposes) look like the same tool and individual cut them. The beginning and finish angles are identical. The chances of that being true in both the gallows construction in 1862 and Meagher's hardware construction in 1864 are unlikely.
